Accident Analysis of Fukushima Daiichi Nuclear Power Plant Units 1-3 ①

Prepared for the Seminar at Politecnico di Milano-Department of Energy

May 17, 2013

The Institute of Applied Energy

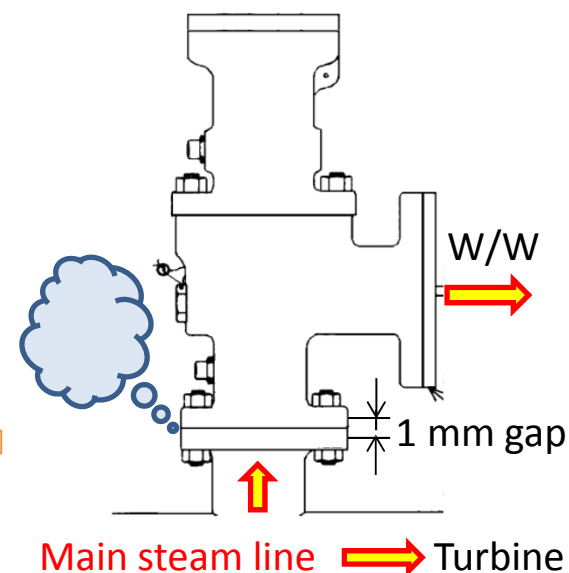
Leakage through top flange gasket

← Deterioration due to high temperature and high pressure

Leakage due to buckling of in-core monitor guide tube

Leakage through SRV gasket

Deterioration of pressure suppression due to partial condensation

← Large temperature distribution

← Insufficient mixing

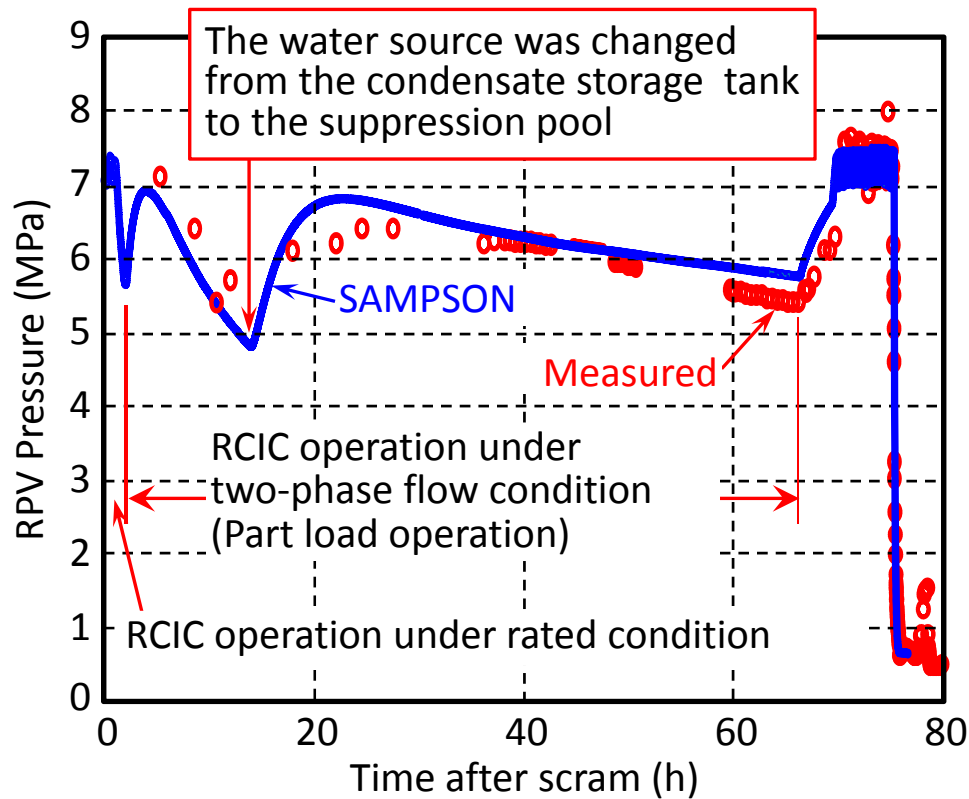
RPV pressure at Unit-2

Partial load operation of RCIC turbine under two-phase flow condition (Unit-2)

- The RCIC was originally designed to automatically work with reactor water level signals: activation with a low water level signal and stoppage with a high water level signal.
- After the SBO, RCIC had continued to work without receiving control signals for the reactor water level.
- In other words, the RCIC did not stop even when the reactor water level exceeded the high water level; then the water level reached the steam extraction piping for the RCIC turbine.
- This meant that the RCIC steam turbine had worked under the two-phase flow condition, which led to deterioration of the turbine performance.

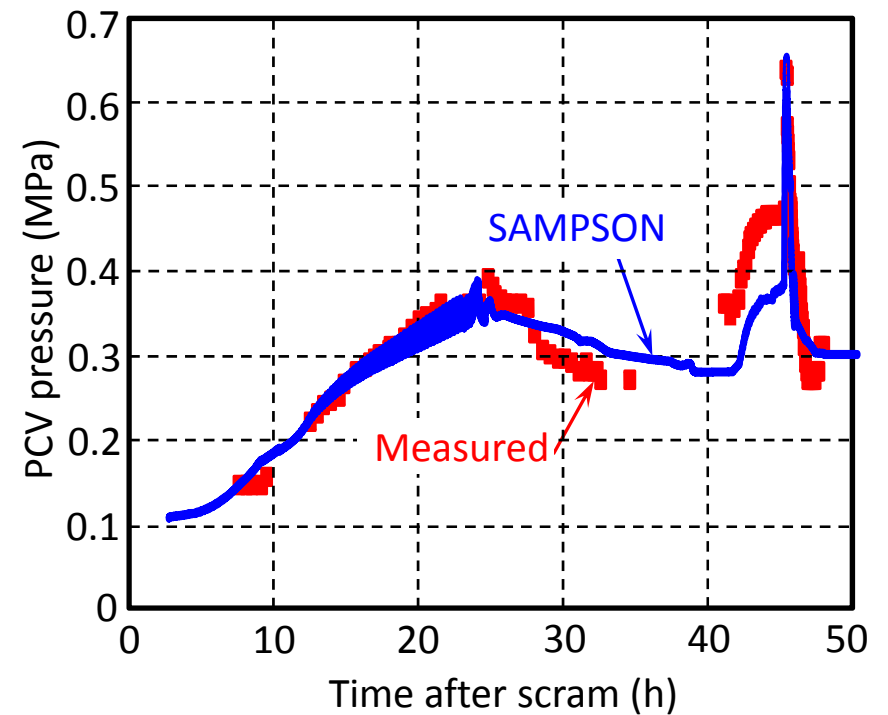
PCV pressure at Unit-3

Partial load operation of HPCI under low pressure condition (Unit-3)

- At Unit-3, after activation of the HPCI, the RPV pressure decreased to about 1 MPa which was almost the lower limit for HPCI operation.
- HPCI performance must be deteriorated under low pressure condition.
- Steam could flow into the suppression pool through the HPCI turbine until the HPCI valve was closed, even after the stoppage of the turbine (or, the stoppage of water injection).
