Accident Analysis of Fukushima Daiichi Nuclear Power Plant Units 1-3 ①

Prepared for the Seminar at Politecnico di Milano-Department of Energy

May 17, 2013

The Institute of Applied Energy

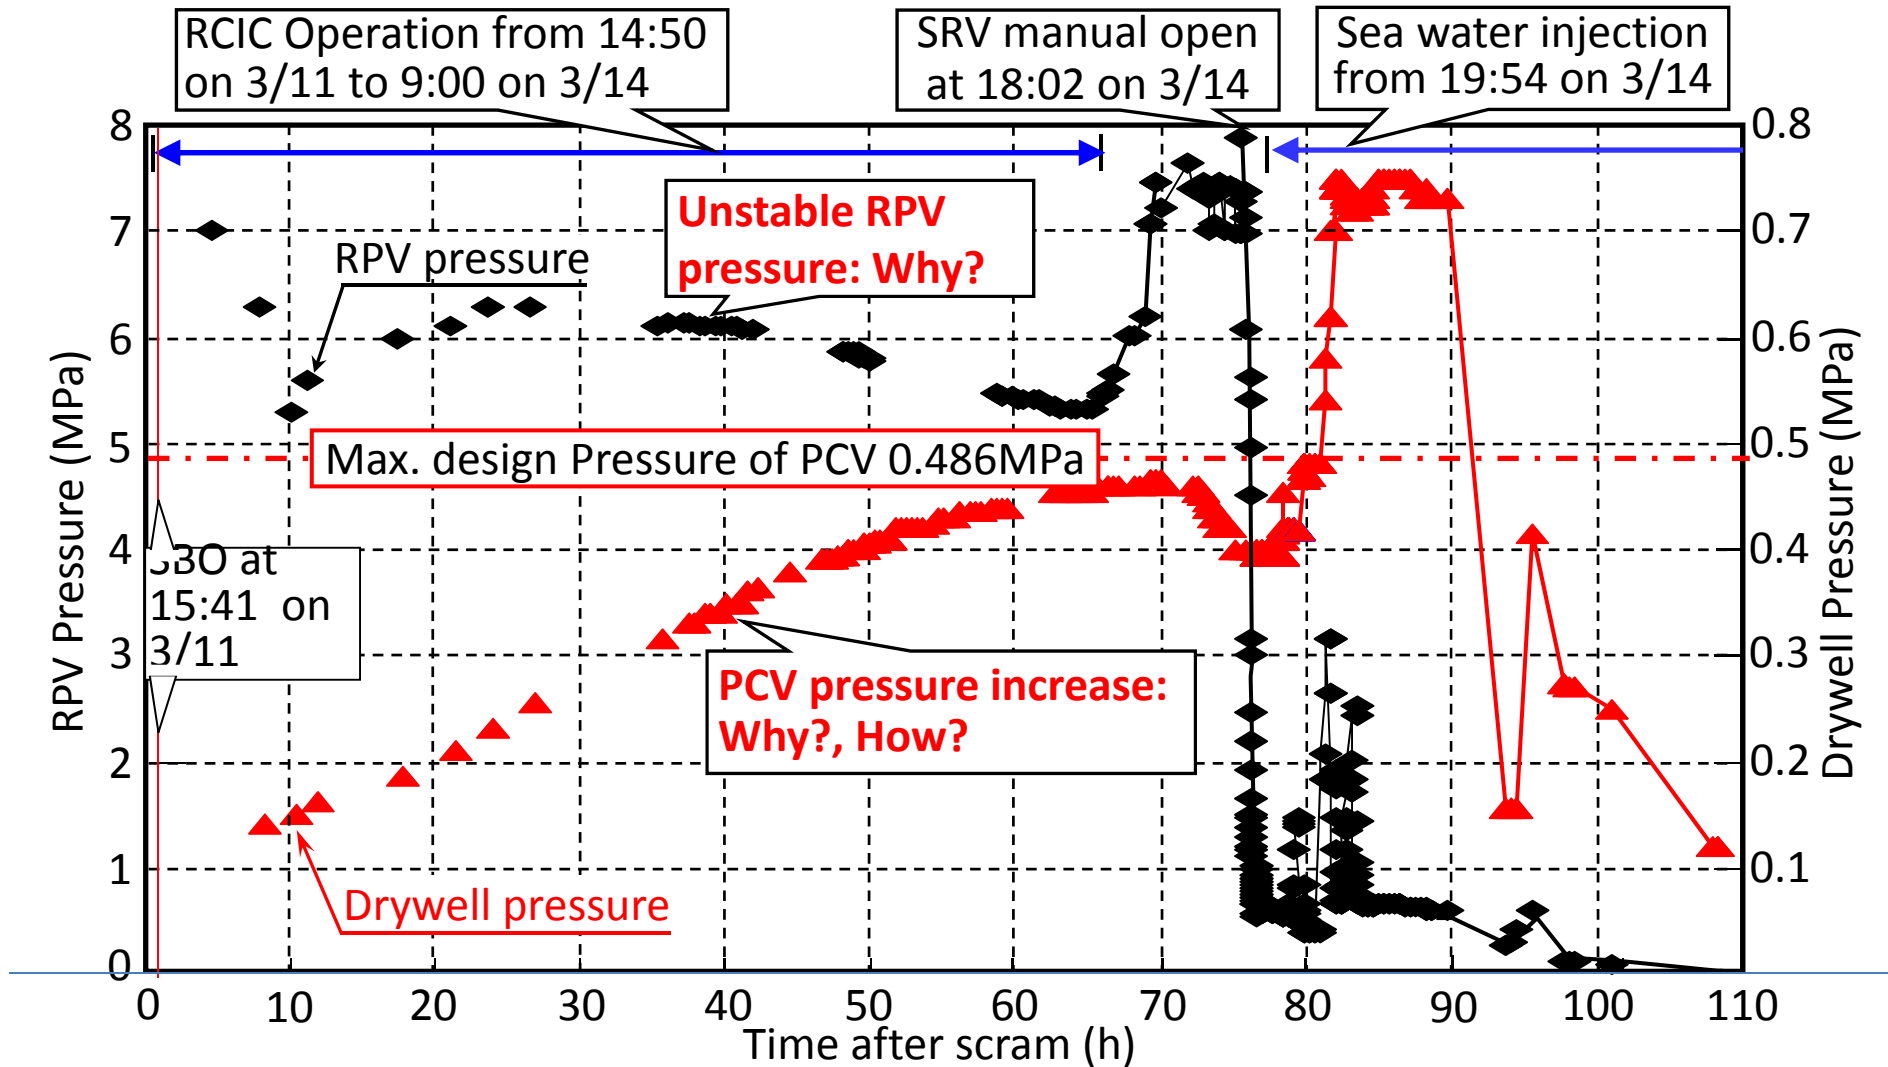
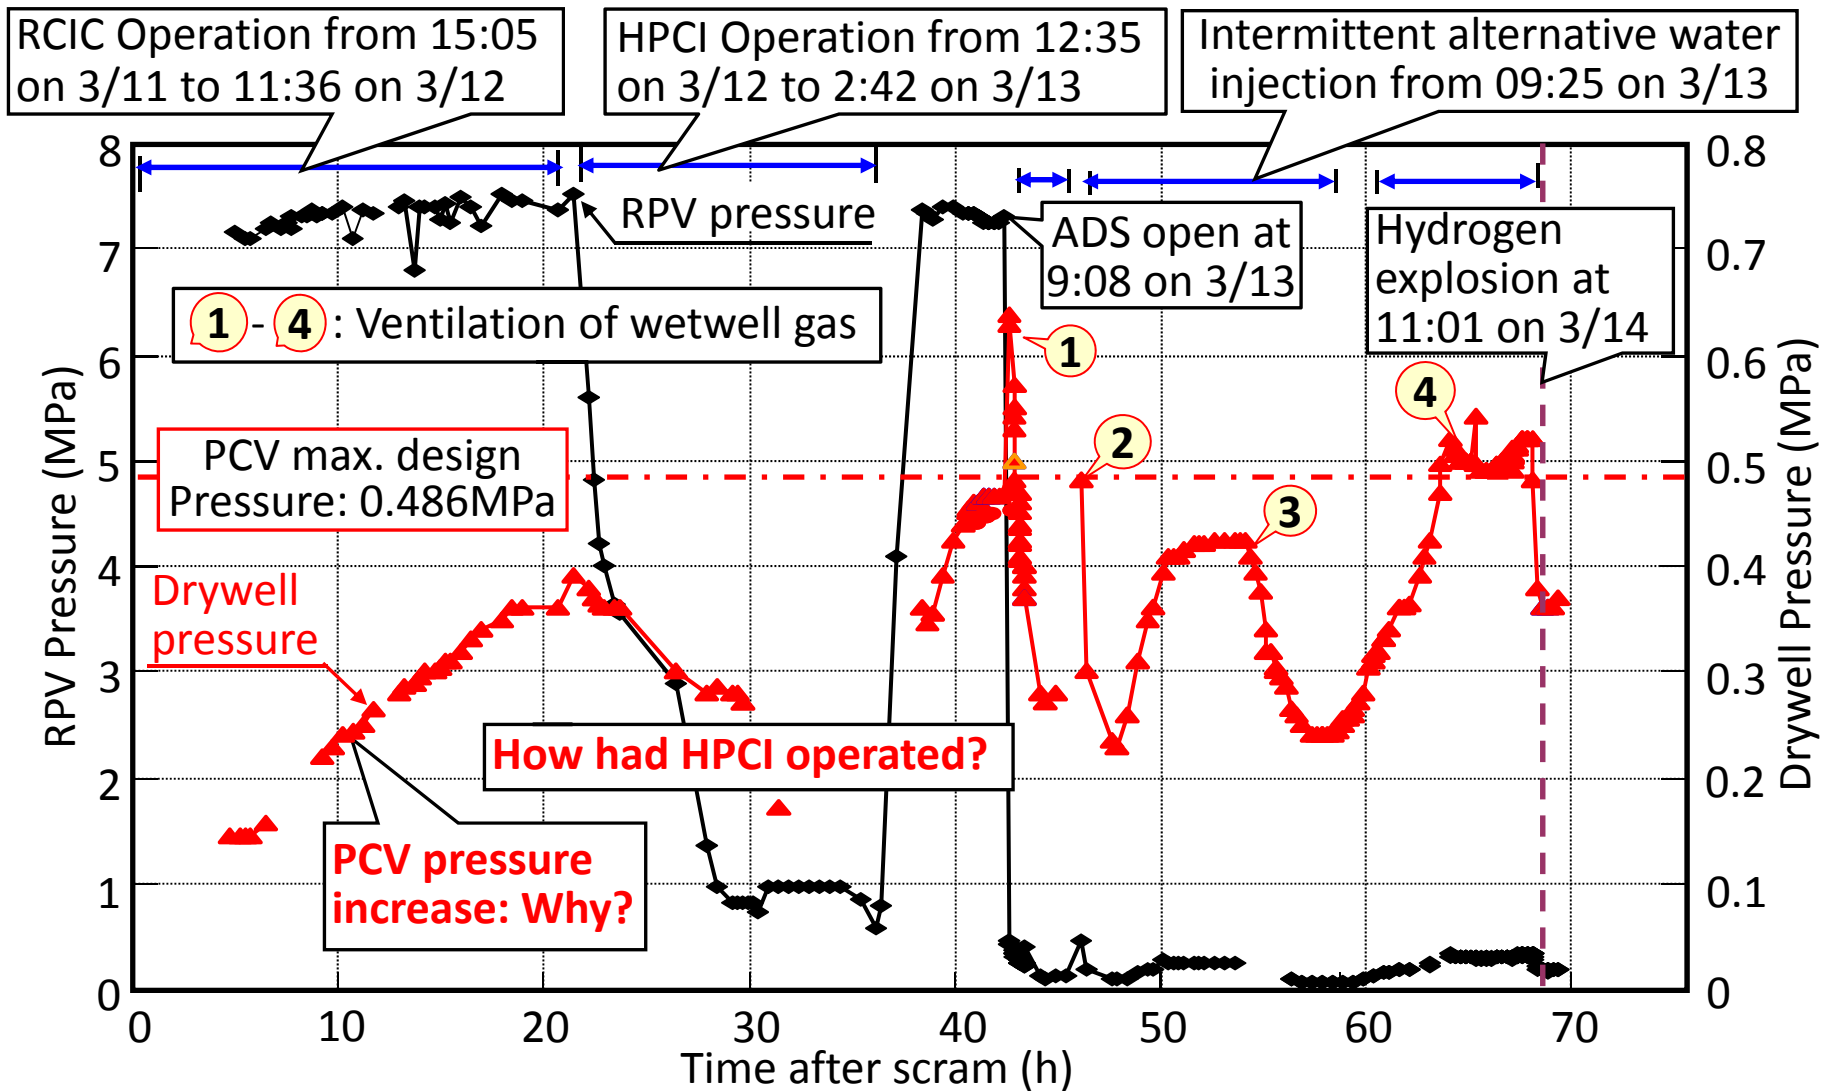
Leakage through top flange gasket

← Deterioration due to high temperature and high pressure

Leakage due to buckling of in-core monitor guide tube

Leakage through SRV gasket

Deterioration of pressure suppression due to partial condensation

← Large temperature distribution

← Insufficient mixing

1. Leakage from SRM/IRM guide tube

crack generation due to buckling was considered.

Application of simplified Von Mises relation: $P_{cr}=0.27E(t/r)^3$

Crack size is still unknown

The current assumption: circumferentially 60 degree crack with 1 mm opening

2. Leakage from gaskets of SRV pipe lines

It was considered that leakage started when the gasket temperature exceeded the design maximum temperature (723 K).

The detailed leakage area of the gasket is still unknown.
